SNAP-8 CORROSION PROGRAM

QUARTERLY PROGRESS REPORT

FOR PERIOD ENDING FEBRUARY 28, 1965

ORNL-3823
4(8)a

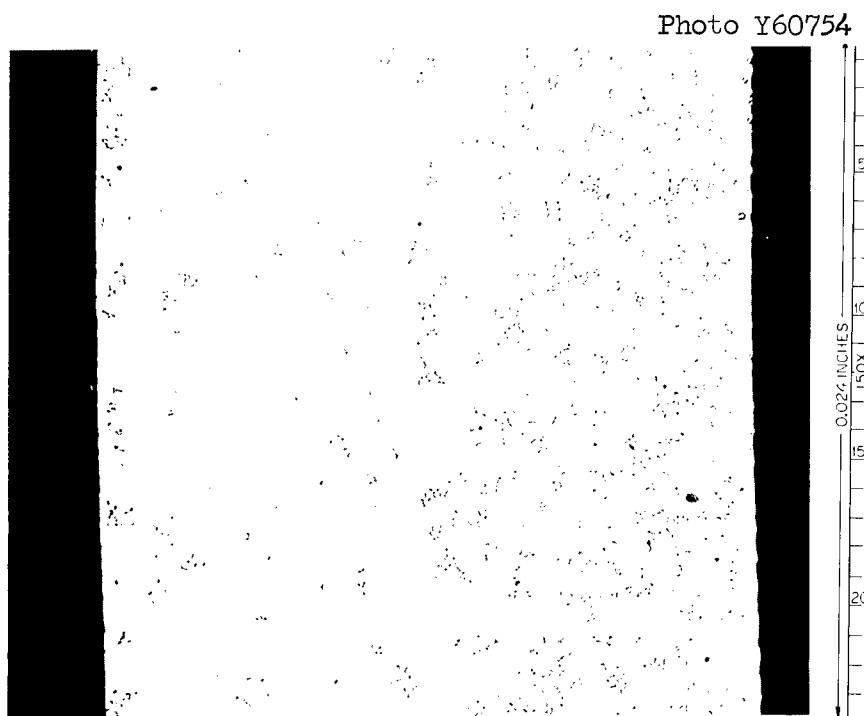
Metallographic examinations of the types 347 and 316 stainless steel insert specimens exposed 2000 hr at 1300°F or higher in all the loops have revealed the presence of several metallurgical phases not originally present in the as-received microstructures. Consequently, some effort has been made to identify the new structures. The exposure temperature of 1300°F and the exposure period of 2000 hr are capable of causing precipitation of such phases as sigma, chi, and metal carbides, with their occurrence being dependent upon the existing chemical balance in the alloy. Several identification methods have been tried, such as the use of dilute and concentrated solutions of Murakami's reagents, as described by Emmanuel.¹² These reagents indicate the presence of both carbide and sigma-phase structures in types 347 and 316 stainless steel. In the type 347 stainless steel specimens (see Fig. 3) the phase indicated as carbides occurred in the portion of the specimen nearest to the surface that had been exposed to NaK, and the phase indicated as sigma occurred in the

Fig. 3. Carbides (Dark Particles) and Sigma Phase (Light-Gray Particles) in Type 347 Stainless Steel Exposed to NaK at 1400°F for 5133 hr. Specimen No. 5, loop 5-5. Surface exposed to NaK is at right side of photograph.

other portion. Since the specimens were undergoing carburization through the surface exposed to NaK, the apparent separation of phases indicates that carbon enrichment was causing decomposition of sigma-phase material. This is consistent with the general theory regarding the sigma phase in austenitic stainless steels. The carbon acts as an austenite stabilizer. It also removes the chromium from the matrix by formation of chromium carbides, and thus it affects the matrix composition in favor of sigma-phase decomposition.

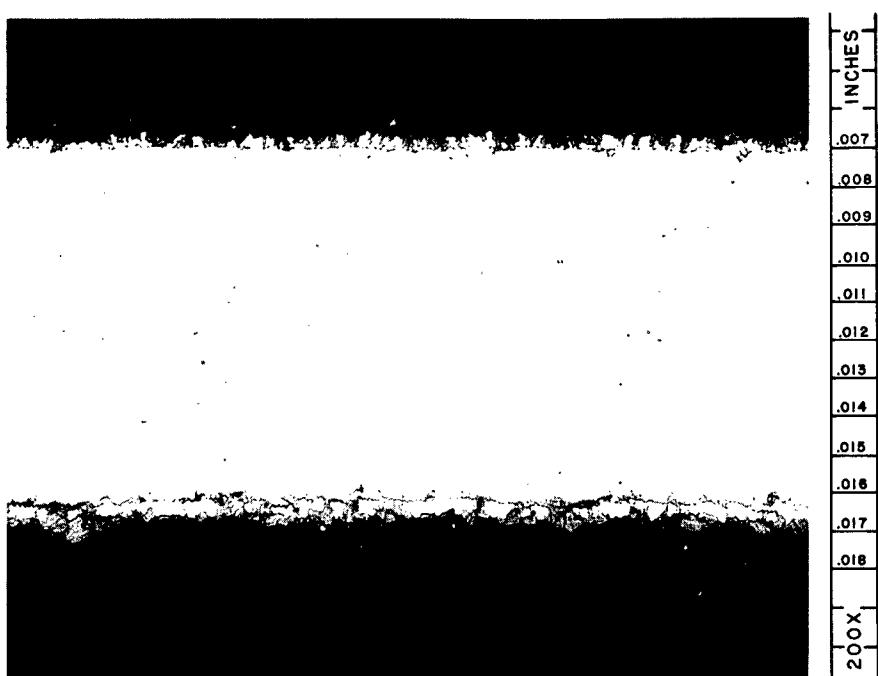
Photo Y56403

Fig. 4. Mass Transfer Products in Loop 9-2, Specimen No. 1. Surface deposits consist of metal particles (bright) and NaCrO_2 (gray).

chromium and contained no iron or nickel. Wet chemical analysis revealed the presence of sodium and thus indicated that the complex oxide is sodium chromite, NaCrO₂.

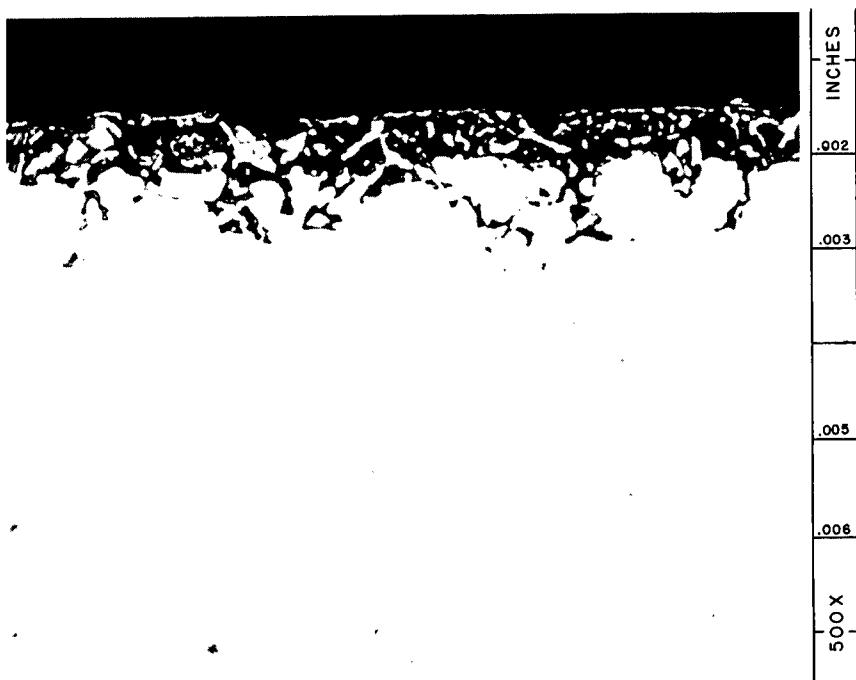
Photo Y60753

Fig. 5. General and Intergranular Corrosion of Hastelloy N Exposed in NaK at 1400°F for 5133 hr. Specimen No. 4, loop 5-5.

to be about 0.5 mil deep, whereas intergranular attack extended about 1 mil beyond the depth of general corrosion. No metallographic evidence of corrosion was found in any of the other materials; however, weight change data showed that the corrosion of type 347 stainless steel at the same temperature was about one-tenth that of Hastelloy N, and type 316 stainless steel located in a lower NaK velocity region was corroded about one-sixth as much as the type 347 stainless steel. The lower NaK velocity is believed to be responsible for the difference in the corrosion rates of these two basically similar materials. Within experimental error, Croloy 9M at 1385°F showed no corrosion. However, considerable carbon migration occurred, as determined by both carbon analysis of insert specimens and metallographic examination. At the hot upstream end of the Croloy 9M piping, the material was decarburized completely across the wall, as depicted in Fig. 6. Two feet downstream at the same temperature, decarburization had proceeded about three-fourths of the way

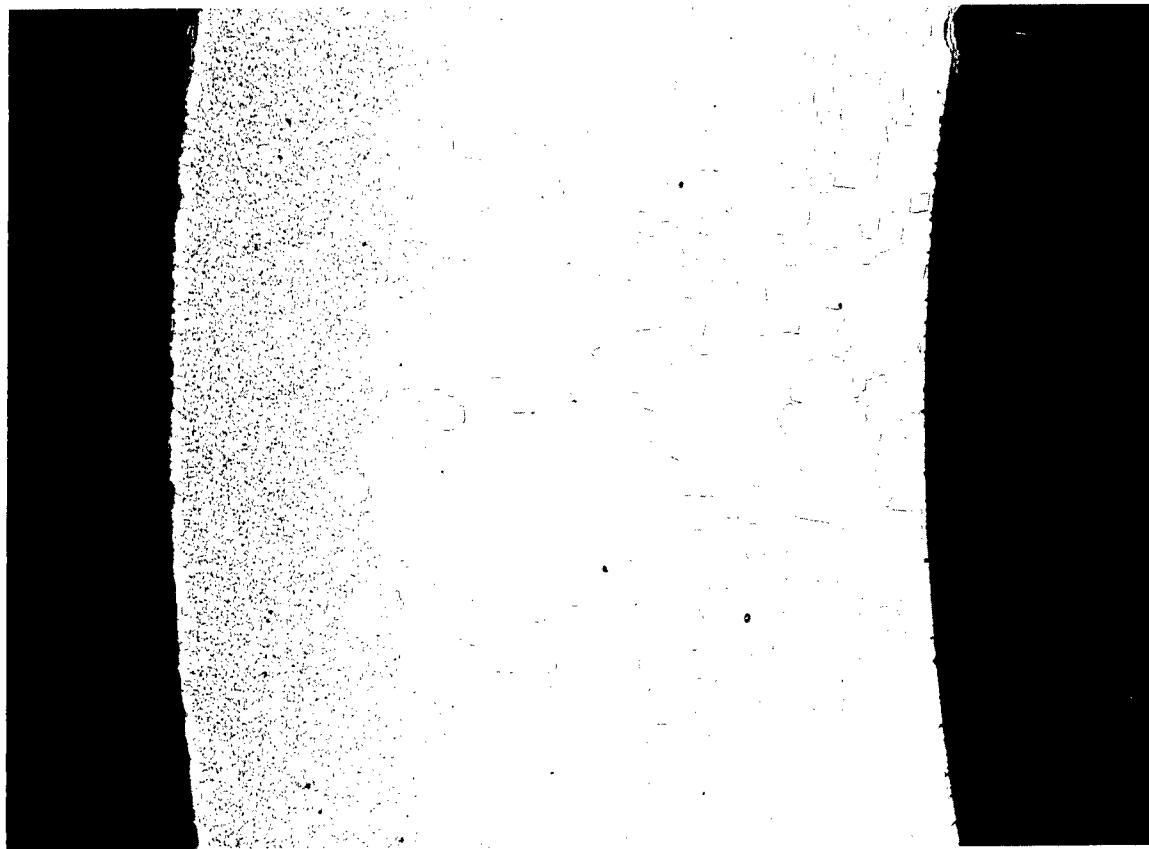
Photo Y60759

across the wall, as shown in Fig. 7. Both figures also reveal the extensive grain growth that accompanied decarburization. The general pattern of carbon migration around the loop was similar to that noted in all previous loops; however, the longer exposure time resulted in a greater degree of carbon migration. The carbon content of type 316 stainless steel at the hot end of the heat exchanger increased from about 0.054% to approximately 0.44%. Metallographic evidence of carburization is shown in Fig. 8. At the cold end of the heat exchanger, Croloy 9M was also carburized as indicated by the pre- and posttest carbon contents of specimens 8 and 9 (see Fig. 9 for specimen location diagram), which increased from about 0.11% to about 0.2%. Metallographic examination did not reveal this, as noted by the relative uniformity of carbides visible

Fig. 7. Decarburized Croloy 9M Piping 2 ft Downstream of that Shown in Fig. 6. Same exposure conditions. 39X

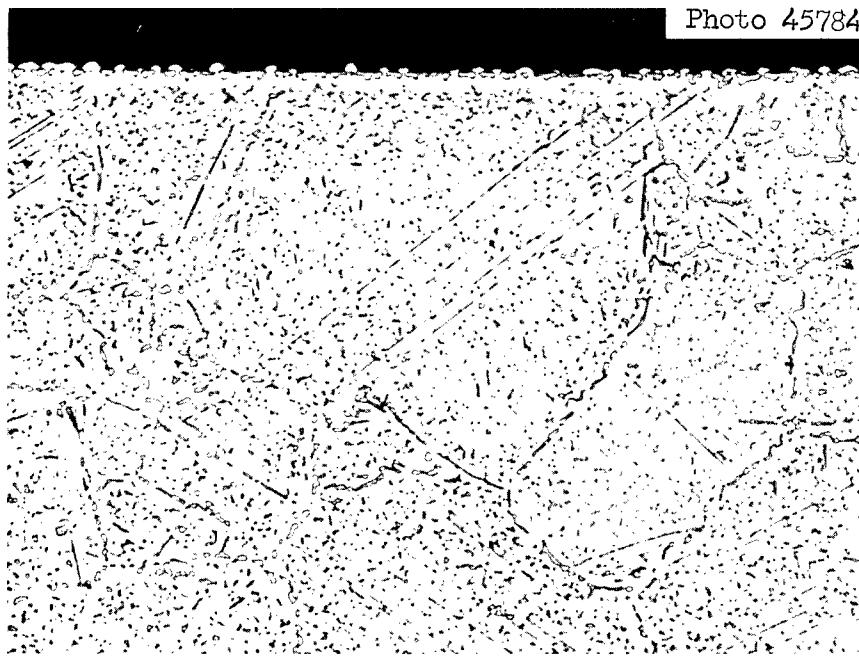
Photo 45784

Fig. 8. Carburized Type 316 Stainless Steel Exposed to NaK at 1283°F for 5133 hr. Specimen No. 16, loop 5-5. 500X.

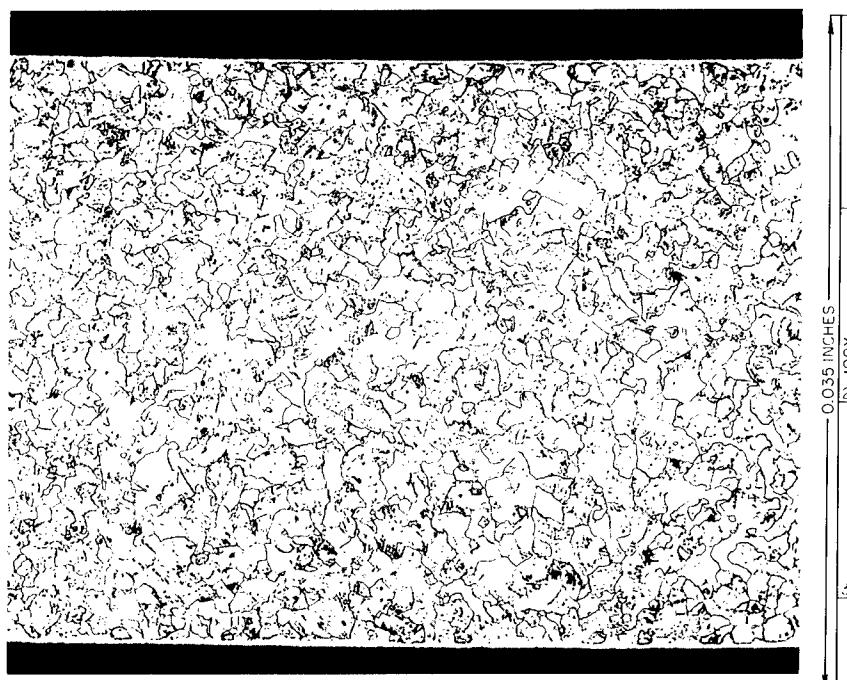
Photo Y60755

in the cross section of specimen 8, shown in Fig. 10. The photomicrographs of Figs. 11 and 12, however, show clearly the difference in the carbide content of specimen No. 9, which was carburized to about 0.2% C, and specimen No. 10, which was decarburized to about 0.03% C. These two pictures also reveal the nickel-rich diffusion layer that resulted from dissimilar metal mass transfer. In the hot-leg portion of the loop, the carbon content of Hastelloy N specimen No. 4 increased from about 0.028 to 0.15%. All carbon contents quoted represent the average for a sample taken across the total thickness of the specimen.

Fig. 10. Carburized Croloy 9M Exposed to NaK at 1110°F for 5133 hr.
Specimen No. 8, loop 5-5.

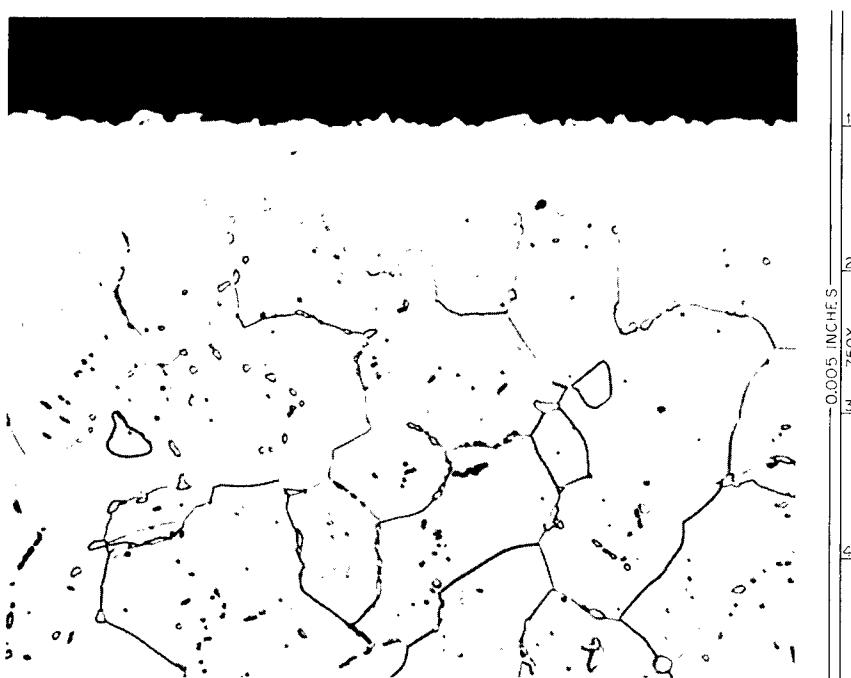
Photo Y60757

Fig. 3.12. Decarburized Croloy 9M Exposed to NaK at 1242°F for 5133 hr. Specimen No. 10, loop 5-5.
